# Annex G: Otter and Water Vole Survey Report

Rail Central

855950

FEBRUARY 2018

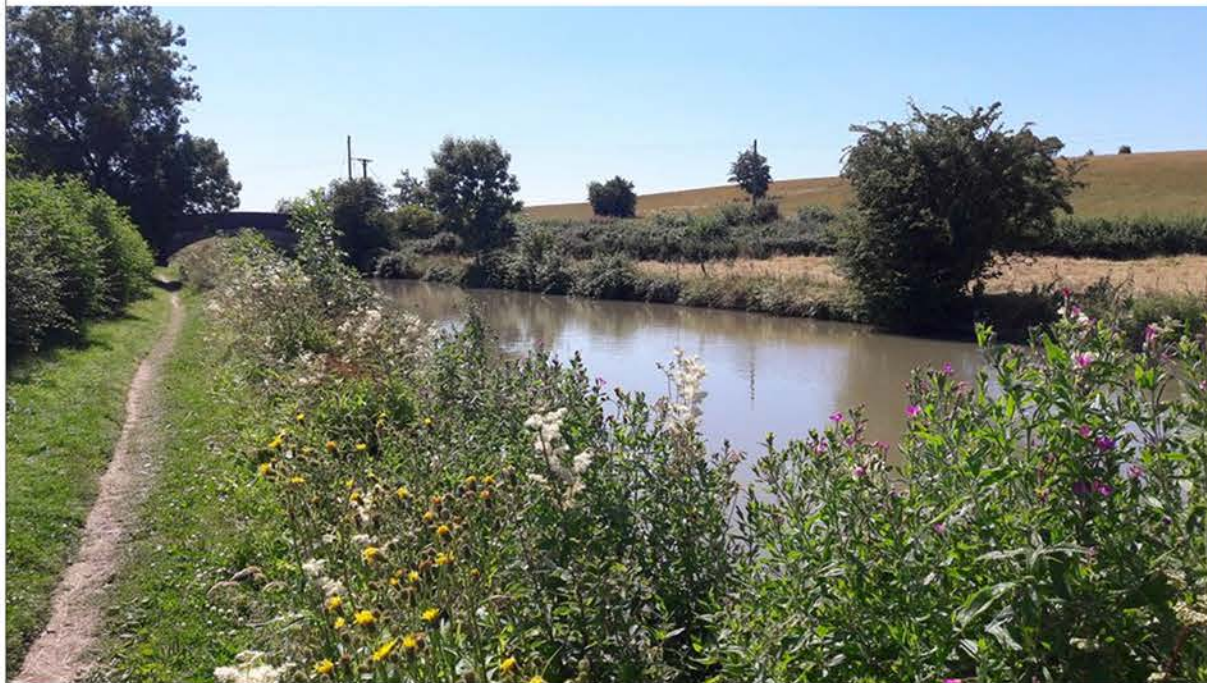
| Watercourse | Habitat Assessment | Surrounding Habitat | Habitat Classification<br>Otter / Water Vole | Otter | Water Vole signs |
|---|---|---|---|---|---|
| 1 | Grand Union Canal , Steep banks, mostly sheet piling but, some areas with substrate soft/suitable for burrowing, consistent water level, tall tussocky grass on bank, 50% cover of in-channel herbaceous vegetation, etc | Woods, pasture , arable, towpath. | Otter, Excellent<br>Water Vole<br>Excellent/<br>Suitable | Present, spraint recorded throughout survey reach<br>(Figure G2.1 and G2.2) | Absent |

- Photo 1 Watercourse 1 (Canal)
- Photo 2 Watercourse 2
- Photo 3 Watercourse 3

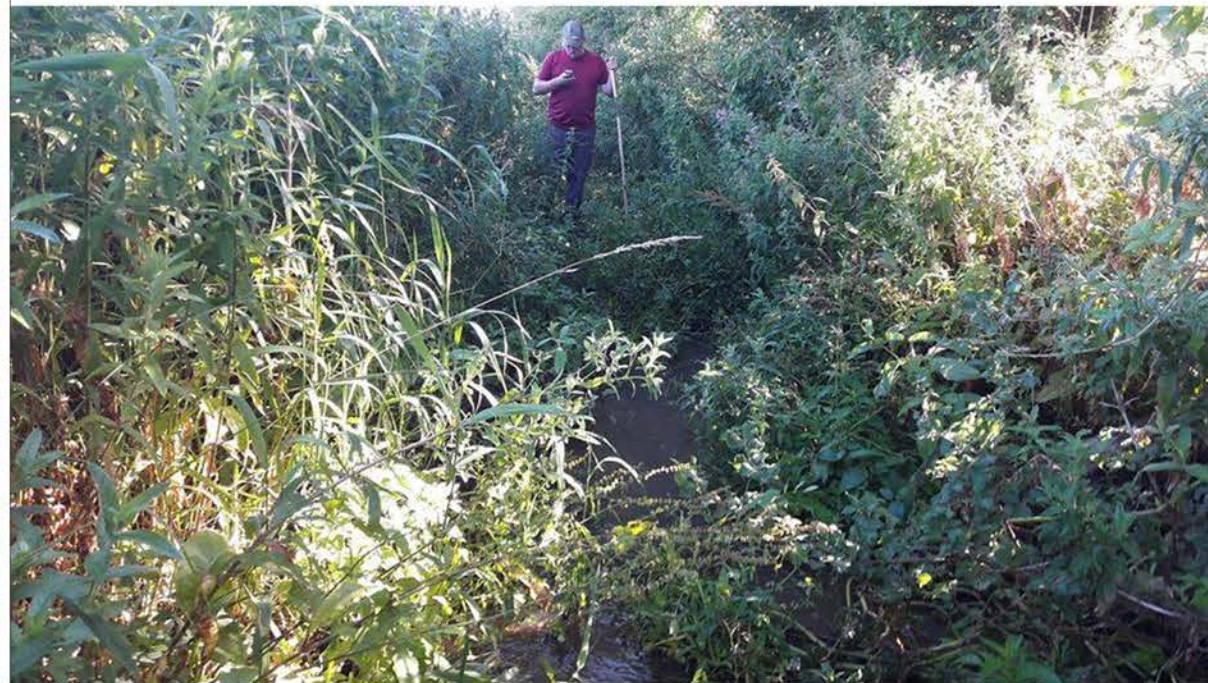
Photo 2

| Watercourse | Habitat Assessment | Surrounding Habitat | Habitat Classification<br>Otter / Water Vole | Otter | Water Vole signs |
|---|---|---|---|---|---|
| 2 | Steep earth banks, variable water level, dense aquatic vegetation , partially shaded in some sections | Arable, scrub, field margins | Otter Marginal<br>Water Vole<br>Suitable | Present. Spraint recorded incidentally at the northern end of the site during surveys for crayfish. | Absent |
