Annex L: Aquatic Survey Report

Fish, Macroinvertebrate, and Crayfish Surveys

Rail Central

Title: Rail Central Aquatic Survey Report

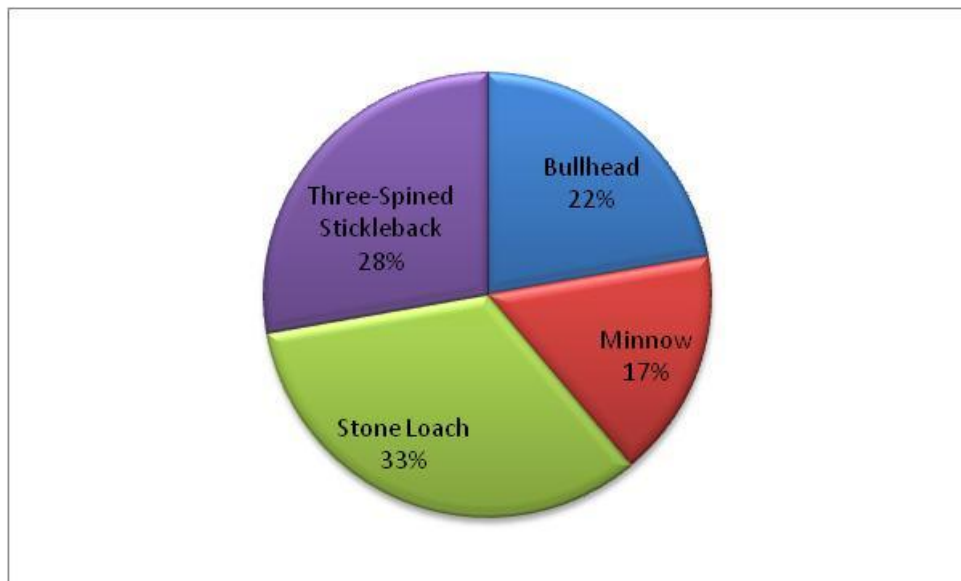
Plate L1. Pie chart illustrating the fish community composition for the Rothersthorpe Stream based on electrofishing catches using a three-run depletion method.

There was very little difference between the species with respect to abundance. Stone Loach was the most abundant overall, with Minnow being the least abundant. The proportion of the total catch for each species caught is illustrated in *Plate L1*.

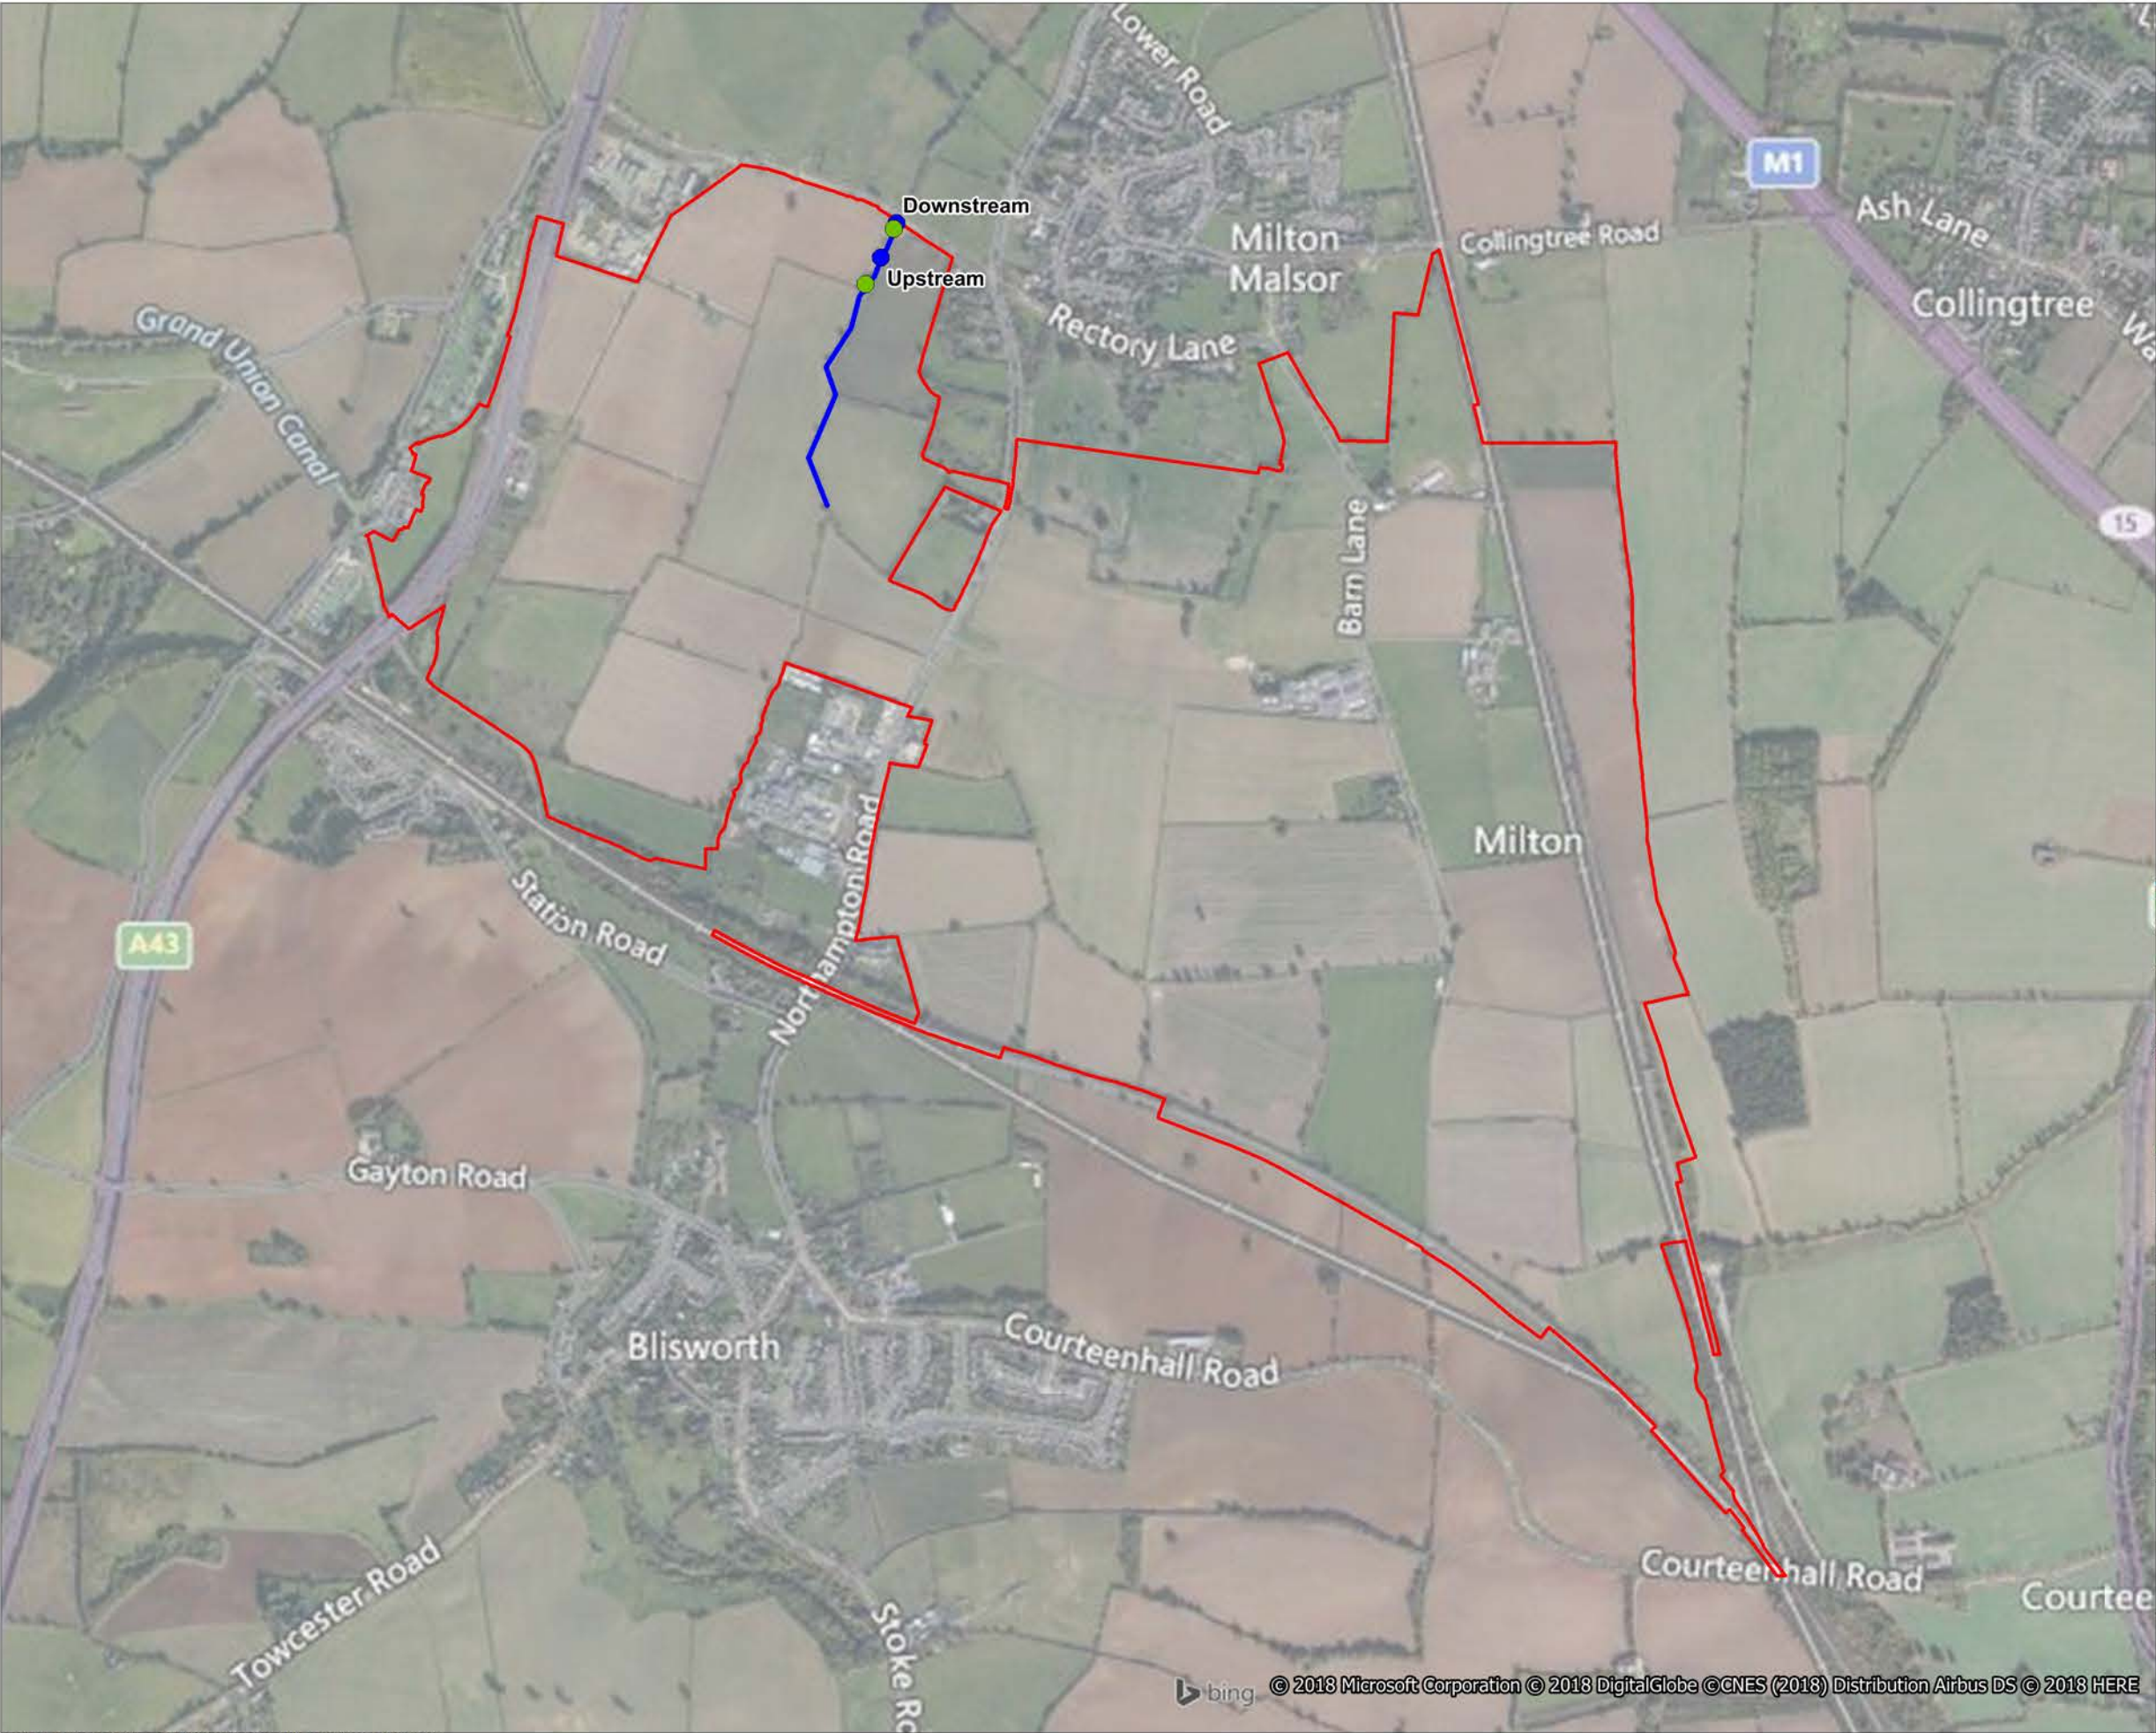
Figure L1.1 – Sample Sites Location Plan

- Site boundary (July 2017)
- Milton Malsor Brook
- Stop net sampling location
- Macroinvertebrate sample location

Figure L1 illustrates the locations of the survey reaches as defined by the upstream and downstream stop net locations. The figure also shows the locations for the aquatic invertebrate samples.

The following sections of this report provide site details, fish and macroinvertebrate survey results for each of the two survey reaches identified in *Figure L1*.
